**DEFENSE NUCLEAR FACILITIES  
SAFETY BOARD**

## Staff Issue Report

**SUBJECT:** Seismic Qualification of Fire Suppression System at the Plutonium Facility, Los Alamos National Laboratory

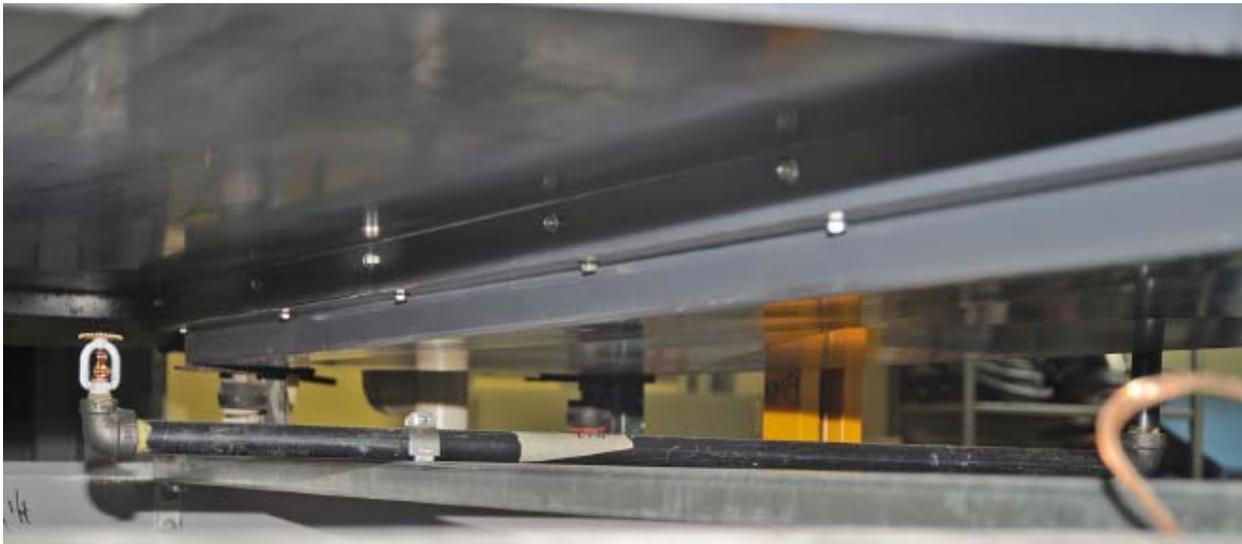
During the November 30, 2015, walkdowns, the staff review team found that a number of the seismic interaction concerns identified by LANS in 2010 still existed [5]. Most notably, large air handlers were installed above fire suppression piping without adequate seismic anchorage and bracing (Figure 1). Damage to the fire suppression piping from falling equipment, such as these air handlers, would lead to a loss of water and hydraulic pressure in the facility, impairing its function after a seismic event. The site's structural engineers could not provide the staff review team with a technical justification for why this condition does not pose a seismic interaction concern. They acknowledged that not all seismic interaction effects have been dispositioned for the FSS.

**Figure 1: Example of fire suppression piping underneath unsecured equipment.**

Additionally, the staff review team noted fire suppression piping supported by non-safety ductwork in several locations. During discussions with site structural engineers, the staff review team asked if these ducts had been evaluated for the FSS’s seismic demands, or if SEWS forms had made assumptions about other systems, such as ductwork, being adequately designed. After a review of the SEWS forms, the staff review team noted that these instances were documented at the time as not being a seismic interaction concern by assuming the support of the ductwork was adequate. These areas of ductwork are not seismically qualified and may fail during a design basis event, damaging FSS piping that would lead to a loss of sprinkler coverage and FSS water leakage.

The Project Execution Strategy (PES) for TA-55 currently estimates completion of walkdowns to identify seismic interaction concerns in July 2016; however, there is no schedule associated with the disposition of any identified seismic interactions that may impair fire suppression function after a seismic event. The staff review team is concerned that not including a schedule to resolve these issues may delay and complicate crediting the FSS for post-seismic fires at PF-4.

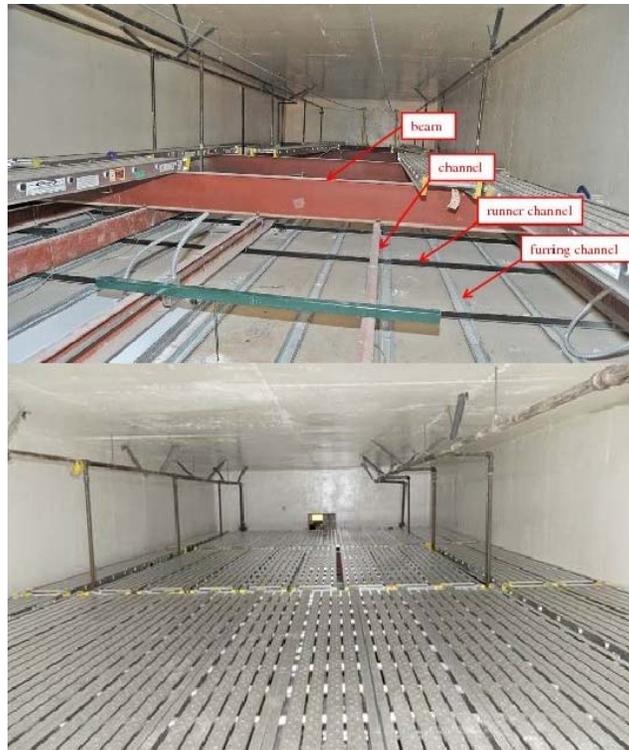
*Configuration Changes to Laboratory Ceilings*—During walkdowns of PF-4, the staff review team viewed one of the laboratory ceiling spaces where LANS has made fire suppression and structural upgrades to the roof girders. Damage or collapse of parts of the laboratory ceiling during an earthquake may damage fire suppression piping and prevent the proper heat activation of sprinkler heads during a post-seismic fire. The staff review team noted that LANS installed significant metal decking that is supported by the laboratory ceiling (Figure 2). This differs from the facility configuration assumed in the seismic evaluation performed in 2011 by LANS's subcontractor [6]. Facility engineers told the staff reviewers that these changes are intended to be permanent.

When asked if this significant increase in dead load and seismic mass added to the laboratory ceilings had been accounted for, LANL staff engineers said that they had not updated this calculation with the configuration changes made since 2011, but believed the added decking would not exceed the dead load assumptions used in the calculations. In further discussions, LANS engineers estimated that the metal decking mass will not challenge the assumed miscellaneous loads on the laboratory ceiling. This condition was not formally evaluated before installation of the decking, and is a lapse in configuration management of the laboratory ceiling. The *Nuclear Safety Management Rule* (10 CFR Part 830) requires evaluating the impacts of configuration changes on safety-related SSCs before they are made [7]. Consistent with the rule, the staff believes that unanalyzed conditions, such as the metal decking, should have been evaluated through the LANS Unreviewed Safety Question process.

**Figure 2: Condition of laboratory ceiling as evaluated (top) and current configuration (bottom).**
