This letter is in response to the Defense Nuclear Facilities Safety Board (DNFSB) letter dated December 17, 2014, requesting an updated plan and schedule for completing the alternate seismic analysis for the Los Alamos National Laboratory (LANL) Plutonium Facility (PF-4).

Description of the Los Alamos Plutonium Facility Upgrades

January 7, 2015

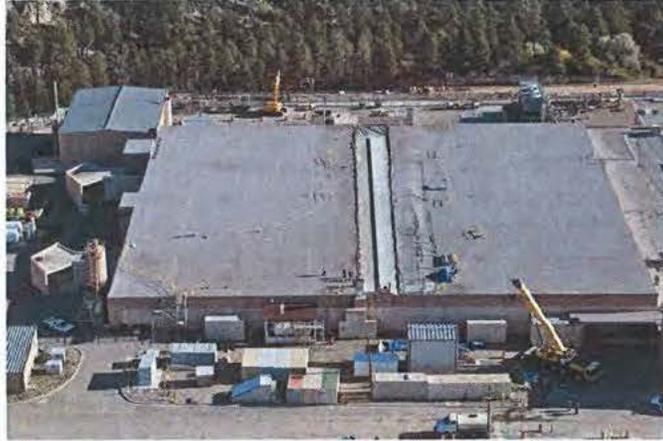
Figure 1. New Drag Strut Across PF-4 Roof

- A 140 ton concrete and steel reinforcement was installed on the existing roof to redistribute loads (Figure 1). This is referred to as the drag strut modification.

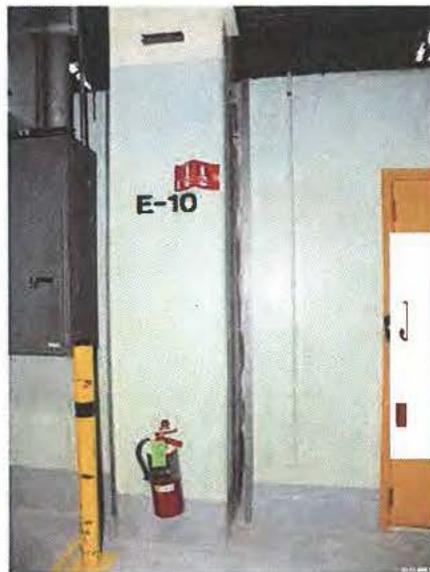
**Figure 2. Captured Column in Plenum Room
(Wall Cut Back 1.5 in.)**

- A gap was cut between the plenum room columns and adjacent structures to allow the columns to move (Figure 2).

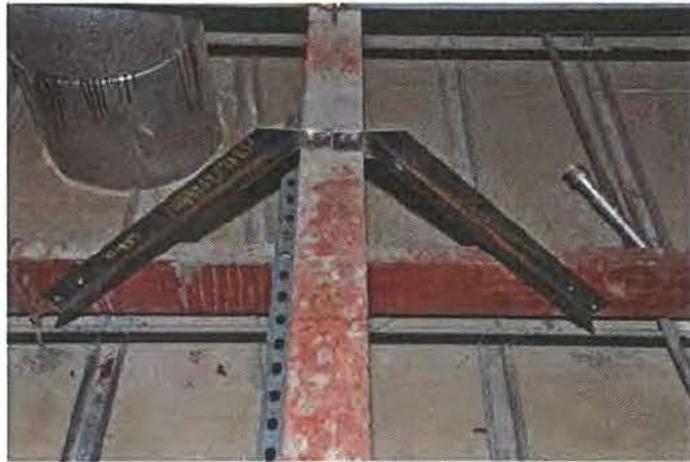
Figure 3. Ceiling Beam Brace from Top of I-beam to C-channel

- Five mezzanines above the main floor were reinforced.
- The top of ceiling beams were anchored to the C-channel beam to provide additional stiffness. In addition, the C-channel beams were stiffened (Figure 3).

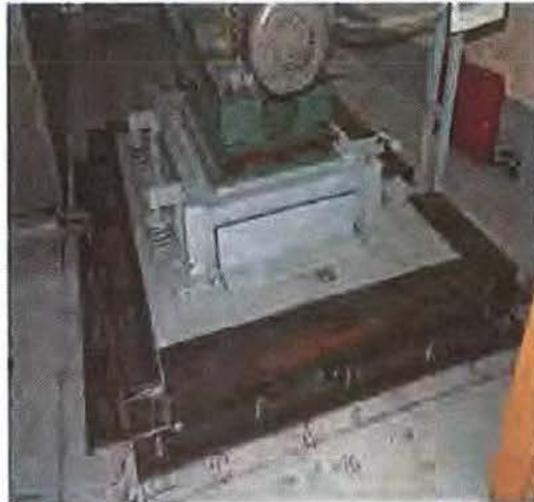
Figure 4. Glovebox Exhaust Fan and Concrete Base Pad with Bracing shown on the Perimeter of the Fan Pad

- Angle irons were installed around the perimeter of the glove-box exhaust fan concrete pads to anchor them to the floor (Figure 4).

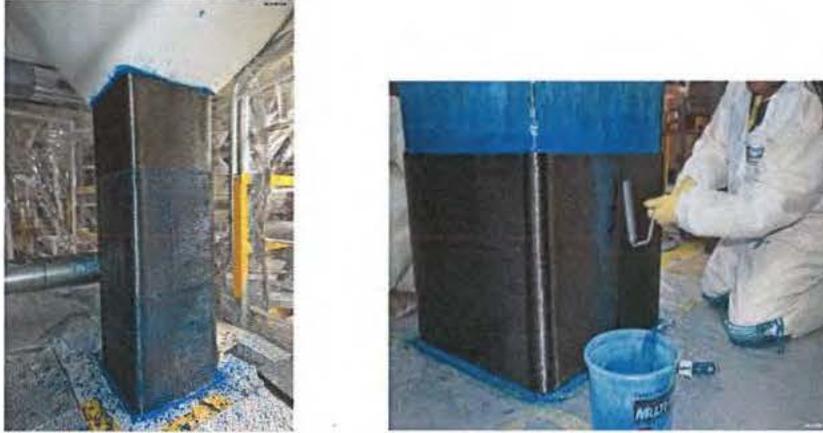
Figure 5. Basement Column reinforcement

- Eight basement columns were wrapped with carbon fiber reinforcement, thereby preventing loss of axial load capacity during and following an earthquake (Figure 5).

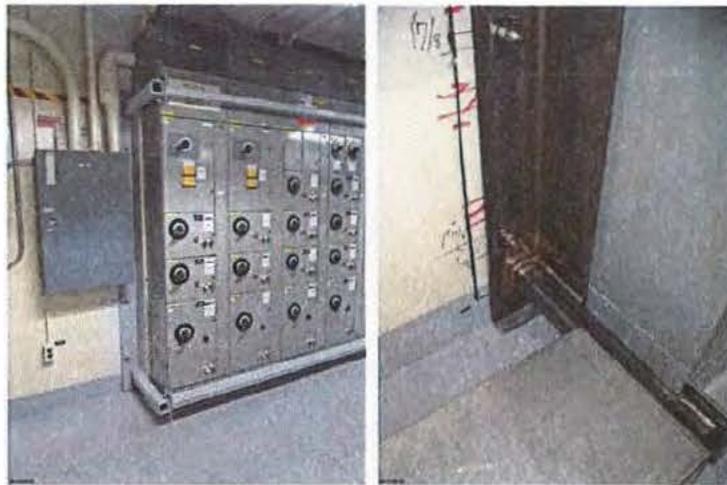
Figure 6. Motor Control System Anchorage

- The Fire Suppression System was upgraded to more effectively mitigate release from a postulated seismically-induced fire scenario.
- Anchorage of essential electrical distribution components has been improved (Figures 6 and 7).
